# **Soil Freeze–Thaw Effects on Bank Erosion and Stability: Connecticut River Field Site, Norwich, Vermont**

Michael G. Ferrick, Lawrence W. Gatto,  
and Steven A. Grant

December 2005

*U.S. Army Engineer Research and Development Center  
Cold Regions Research and Engineering Laboratory (CRREL)  
Hanover, NH 03755-1290*

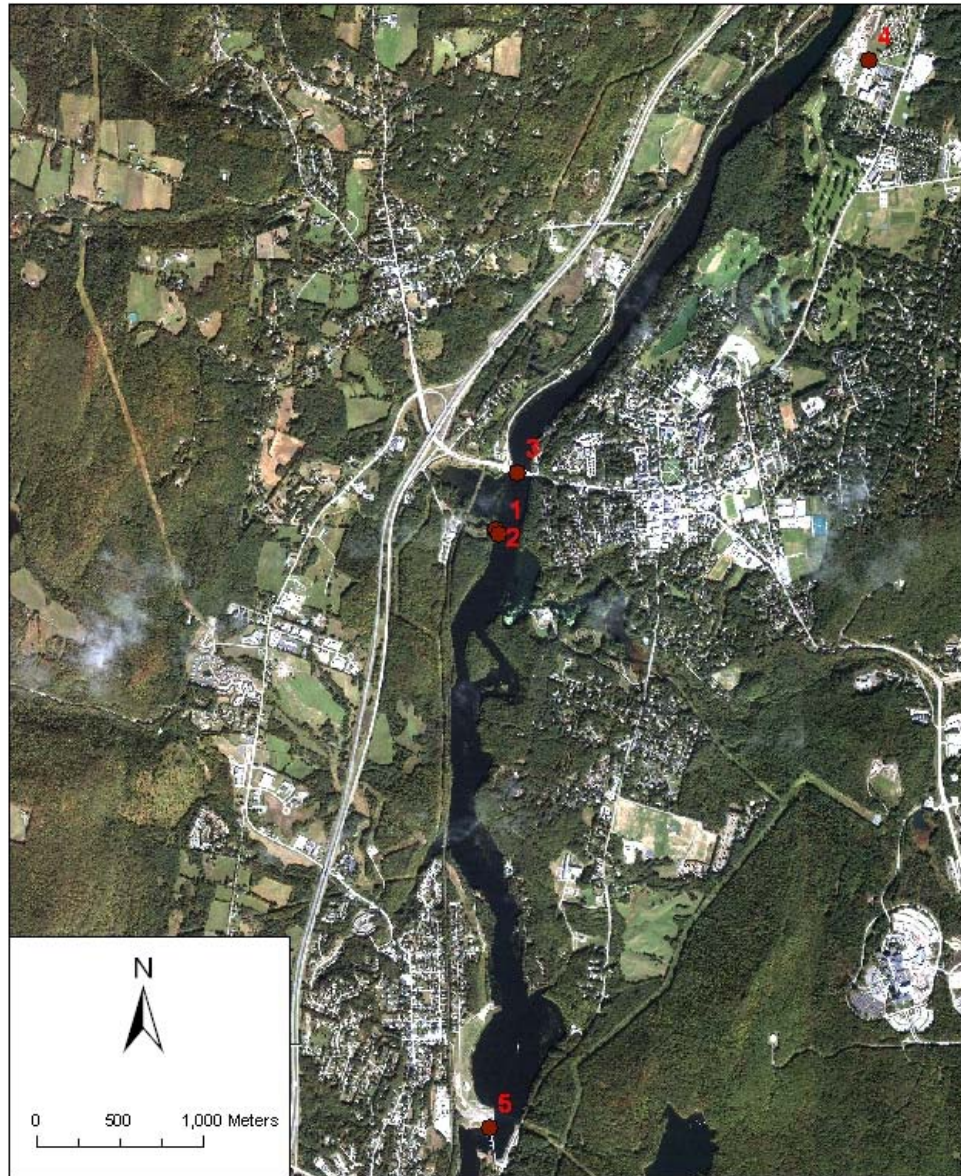
**Figure 1.** Aerial photograph showing location of the Connecticut River reach that contains the study sites. The river is the border between New Hampshire (east bank) and Vermont (west bank). The urban area in New Hampshire is the town of Hanover, and the interstate highway in Vermont is I-91. The numbered bank recession study locations are: 1) north-facing bank site; 2) east-facing bank site; 3) south-facing bank site; 4) meteorological station at CRREL; and 5) Wilder Dam.

The banks along the Connecticut River at the monitored sites are approximately 4-m high, with slopes of about 52°, all in the town of Norwich, Windsor County, Vermont. Figure 1 shows the reach of the river, which includes the study sites, from Wilder Dam in the south upstream to CRREL. The south-facing bank site is located immediately south of the western abutment of the Ledyard Bridge between Norwich and Hanover, New Hampshire. The approximate coordinates of this site (reference WGS84/NAD83 datum) are UTM 18 717436E 4842447N. The soil at this site was mapped as an udorthent or an udipsamment, and the vegetation is grass and brush. The north-facing and east-facing bank sites are located across one large and one small inlet south of the south-facing site, directly east of the Montshire Museum. The approximate coordinates of these sites are UTM 18 717395E 4842127N. Mechanical analysis by Villars\* indicated that the soil at these sites should be classified as either a Hartland silt (a coarse-silty, mixed, active, mesic Dystric Eutrudept) or Unadilla silt (a coarse-silty, mixed, active, mesic Typic Dystrudept). Vegetation is mixed forest, including oak, beech, sugar and red maple, hemlock, and white pine.

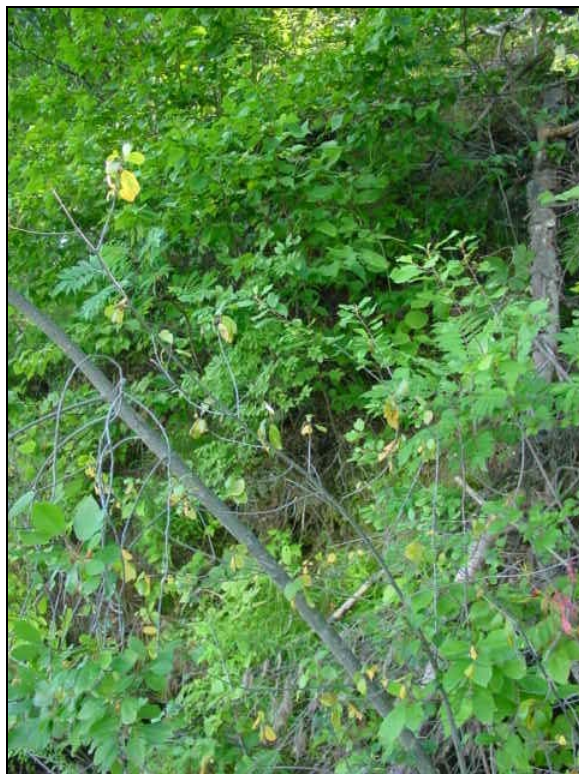
**Figure 2. Densely vegetated “upstream” bank profile line from July 2005.**

Survey lines denoted “upstream,” “instrument,” and “downstream” profile the east-facing bank and delineate the study reach. The surveyed profile lines were photographed to visually characterize the site. Figure 2, taken in July 2005, shows the heavily vegetated “upstream” bank profile line. About 15 m downstream of this line is the “instrument” bank profile line, depicted in Figures 3, 4, and 5. Figure 3 shows variable snow depth on the bank and ice cover on the river in March 2003. Figure 4 shows this location in July 2005 with the bank-face instrument clusters highlighted by arrows. Figure 5 presents close-up views of a sediment source and resulting cavity just below the forest root mat (Fig. 5a), and deposition of this sediment on the bank face at the lower instrument cluster near the base (Fig. 5b). A close-up of the natural rock armoring developed at the base of the bank is shown in Figure 6. Finally, Figure 7 shows the revegetating “downstream” bank profile line in July 2005, about 25 m downstream of the instrument line.

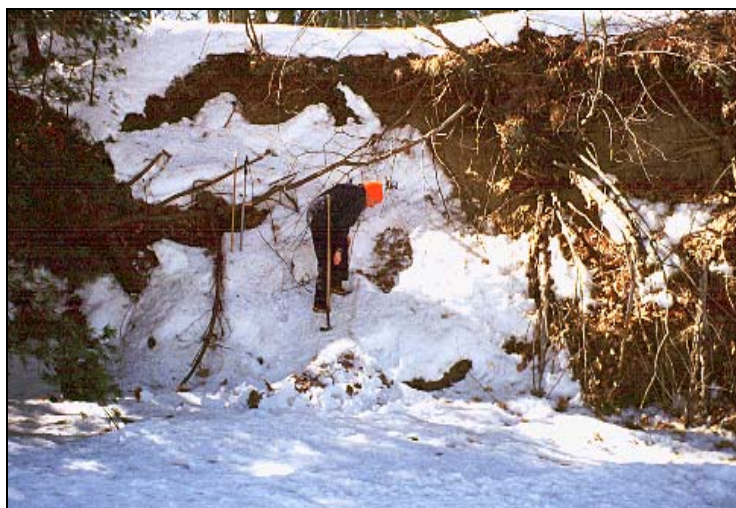
**Figure 3. “Instrument” bank profile line from winter 2003.**

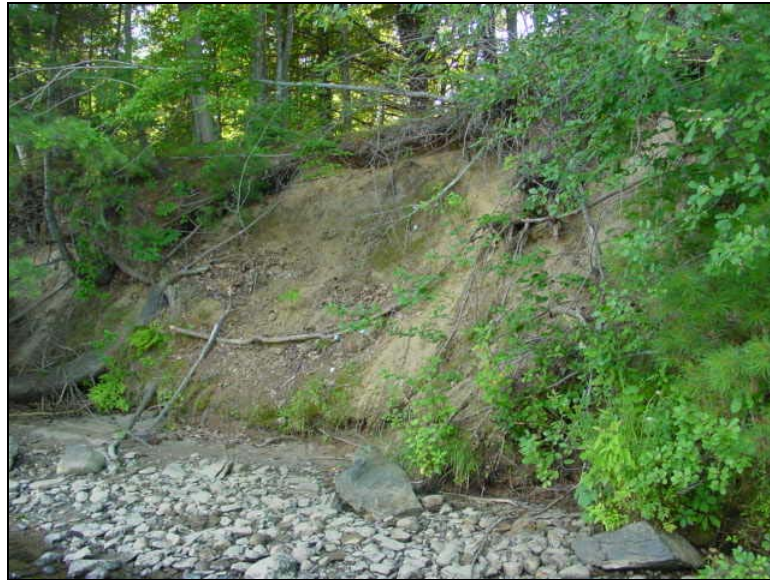
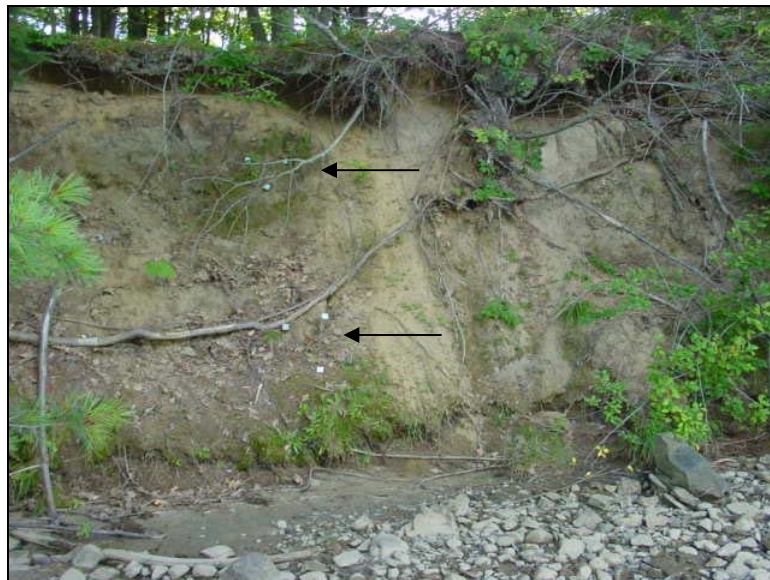
a. From slightly upstream.

b. From slightly downstream.

Figure 4. “Instrument” bank profile line from summer 2005, with bank-face instrument clusters indicated by arrows.

The profile lines are compared with each other for each of the years of the study in Figure 33. In this form the changes along each profile can be more readily discerned, and similar average slopes are evident. Bank recession has proceeded steadily along all three profiles, and slope similarities are maintained through time despite variable soil characteristics and large differences in density of the vegetative cover. These similarities together with significant erosion at the base of the bank (Fig. 4) indicate that a primary forcing is by hydraulic processes of the river. Waves and fluctuating water levels of Wilder Reservoir were active in removing both fine sediments and native materials from the base of the bank (Fig. 4 and 6) over the full monitored length.

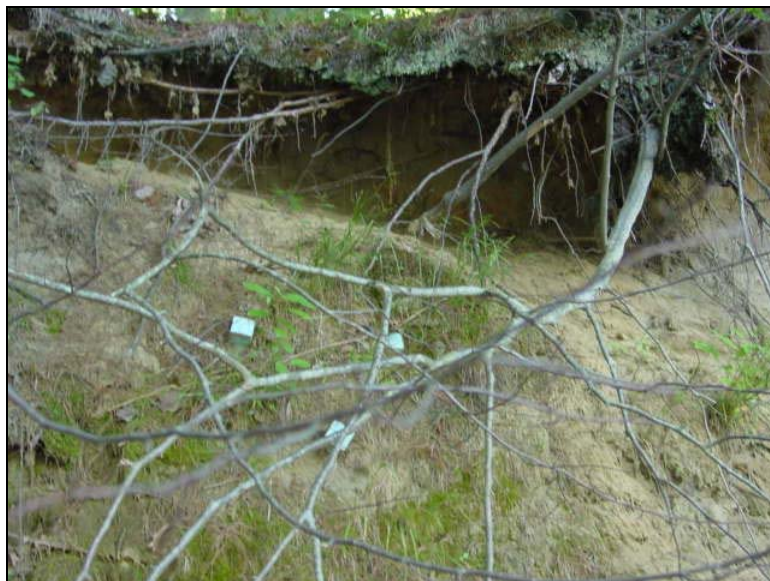
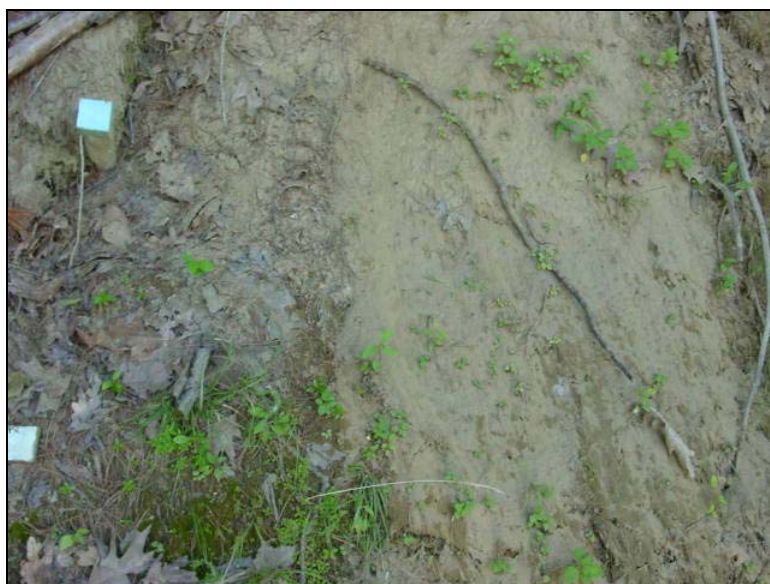
**a. Top of bank sediment loss from just below the vegetated forest floor.**

**b. Sediment deposition, from the source above, on the bank surface near the lower instrument cluster.**

**Figure 5. Close-ups of “instrument” bank profile line from July 2005.**

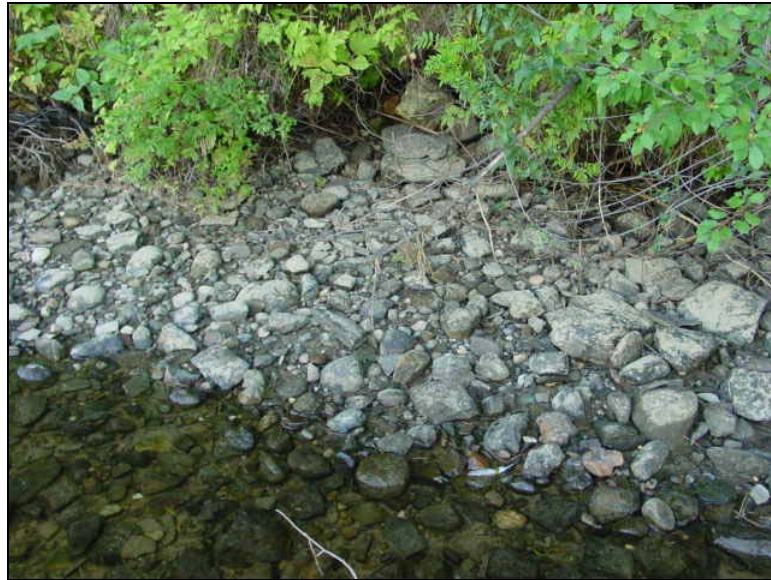
**Figure 6. Close-up of natural rock armor that has developed at the base of the receding bank.**

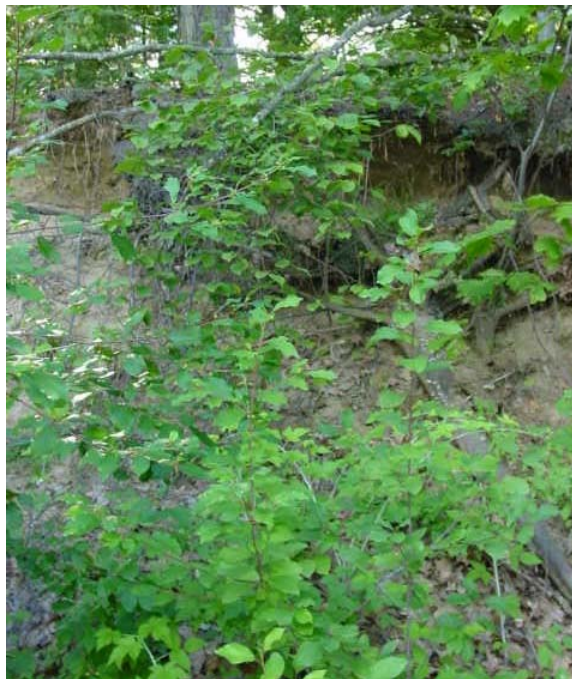
**Figure 7. Revegetating “downstream” bank profile line from summer 2005.**

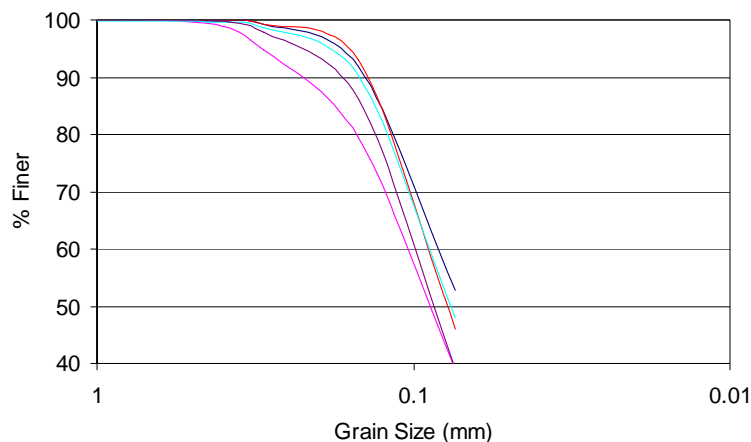
**Figure 8. Soil particle size distributions from the east-facing bank between “upstream” and “downstream” profile lines.**

Five soil samples were obtained on 18 June 2003 from the east-facing bank between the upstream and downstream profile lines and between 0.5 and 3.7 m above the water line. On average, 55% of the bank soil is very fine to coarse sand, 30% is very fine to coarse silt, and 15% is clay-sized. Figure 8, giving the particle-size distributions from sieve analysis, clearly indicates measurable variability among the samples. In addition, Table 1 provides moist and dry unit weights, void ratios, porosities, gravimetric and volumetric moisture contents, and saturation of these soils at the time of sampling. Soil moisture varied significantly among the samples, but porosity was uniformly high. During instrument installation, we noted that the soils of the nearby north-facing bank were similar to those of the east-facing bank.

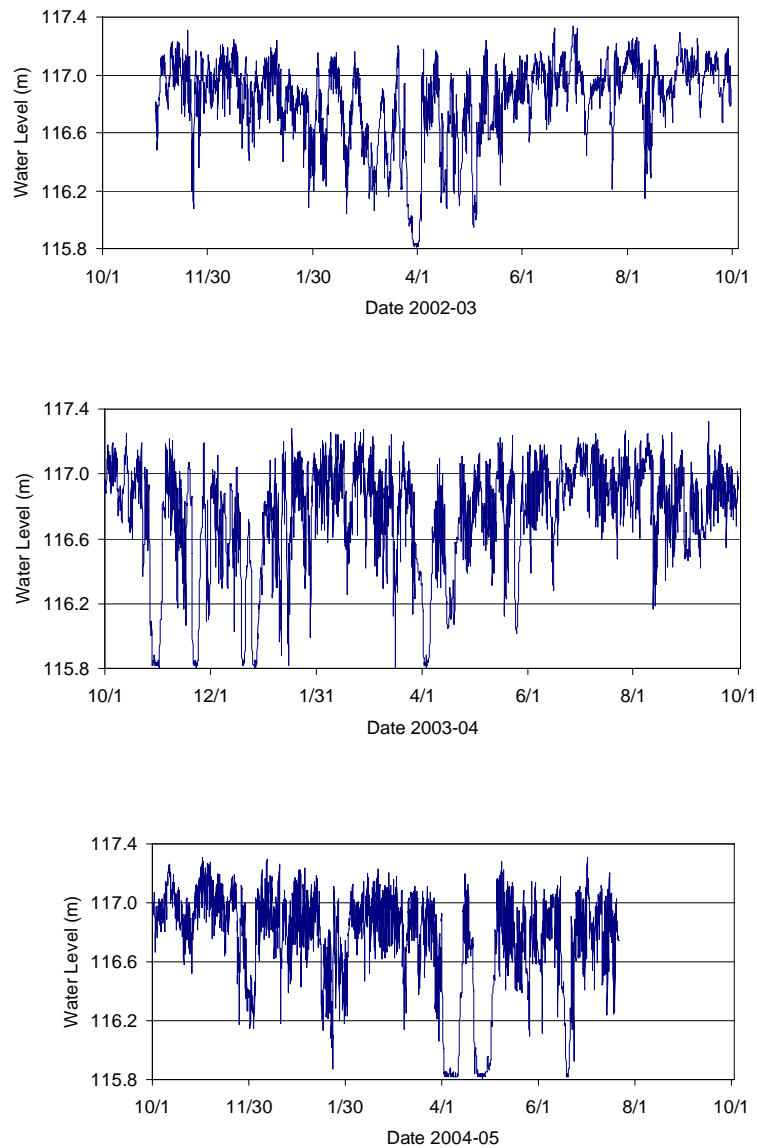
**Figure 9. Wilder Reservoir water level (m) throughout the study period.**

Wilder Reservoir water levels are given by water year for the 3 years of the study in Figure 9. Water level fluctuations over a 1.5-m range represent normal operating conditions. Spring, fall, and winter drawdowns to the bottom of the operating range can be noted in Figure 9, and usually occur in anticipation of greatly increased runoff from the basin. At minimum pool there is a large beach adjacent to the monitored section of bank, while at pool levels of 117 m and above, the water makes direct contact with the bank. To better comprehend the water level data, Table 2 provides statistics through the study period in 6-month intervals for fall-winter and spring-summer. These intervals were selected so that each includes historical high flow (fall, spring) and low flow (winter, summer) periods. The mean, standard deviation, and range are all quite consistent through time for these intervals. The mean water level is about 0.25 m below the base of the bank, but higher water levels that directly contact the bank occur regularly throughout the year.

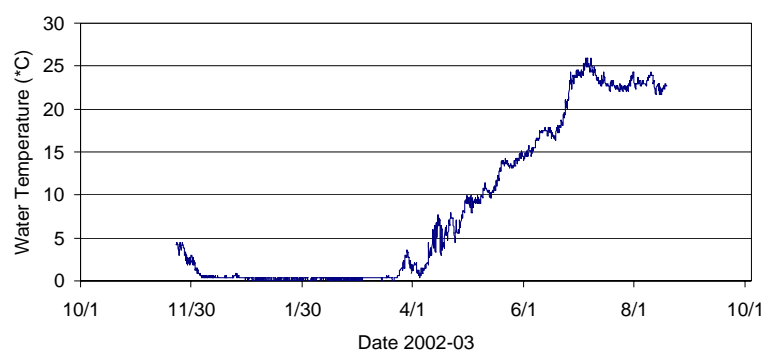
**Figure 10. Wilder Reservoir water temperature (°C).**

The period of ice cover on the reservoir can be discerned from water temperature measurements at the site, given in Figure 10 for the fall of 2002 through the summer of 2003. This water temperature record is abbreviated because the offshore logger was buried by sediment deposition and could not be retrieved for downloading the following summer. However, the ice-cover period and water temperature range recorded in 2002–03 are very typical of other years. The ice

cover formed in early December, and persisted late into March. Ice formation began with the growth of shore-fast ice in protected areas. These ice shelves gradually expanded into the river, narrowing the width of open water until ice floes moving downstream bridge the channel. The ice cover formed in this low stream gradient environment is smooth, with an average late-winter thickness of about 50 cm. Ice breakup in this reach is largely thermal, with most of the ice melting in place. Water velocity near the monitored bank is generally low throughout the year as a result of the large 100-m wide and 6.5- to 8-m deep channel cross-section, reservoir drawdown at high flow, and sheltering by upstream shoals. As a result of all these factors, the impact of the river on bank recession at the site is limited to small waves and fluctuating water levels.

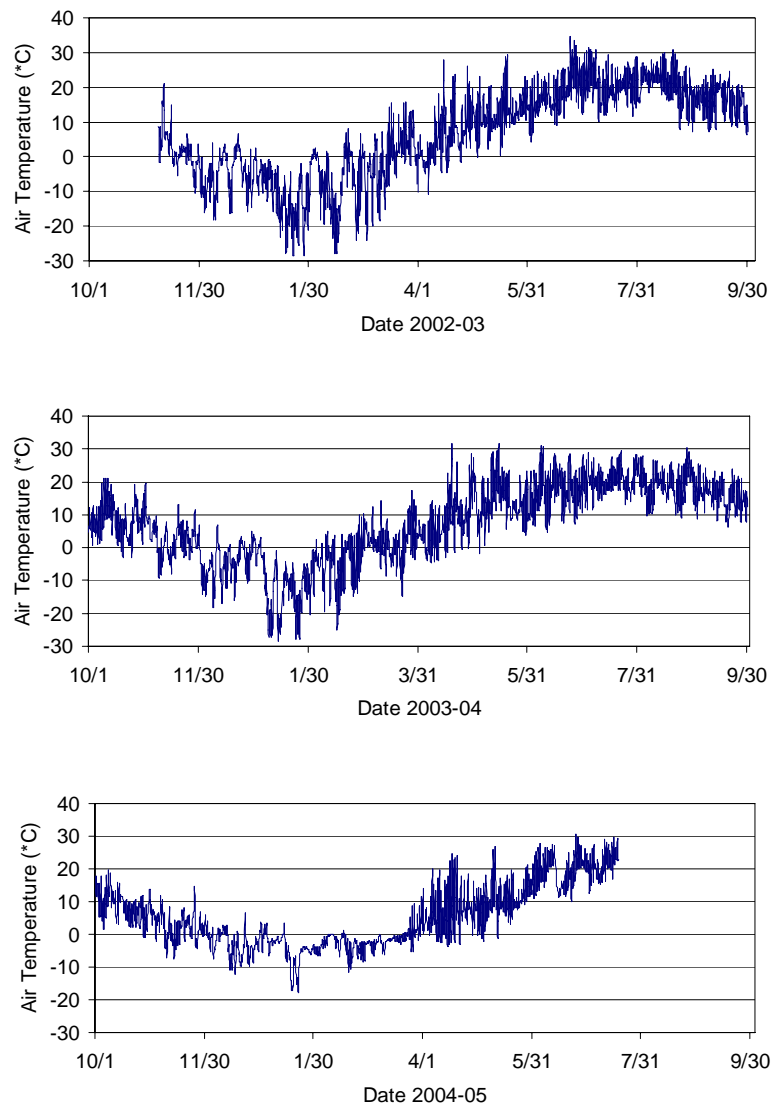
**Figure 11. Air temperature (°C) at 1.5 m above the ground on the upland surface and under the forest canopy at the east-facing and north-facing bank sites in Norwich, Vermont.**

Air and soil temperatures were measured during the period from 8 November 2002 to 19 July 2005. Air temperatures measured at the top of the east-facing and north-facing banks, under the forest cover, are given in Figure 11 for the period of the study. These air temperatures and all subsequent soil temperatures are displayed by water year. The low-frequency seasonal and high frequency diurnal changes in air temperature can both be readily discerned. The period of sub-freezing air temperatures extends from the beginning of December until mid- to late March, well aligned with the ice cover period on the reservoir. Minimum temperatures in January approached  $-30^{\circ}\text{C}$  in 2 of the 3 years of data collection. Diurnal temperature changes often exceed  $20^{\circ}\text{C}$ , typically in winter and spring. Maximum air temperatures occur in June through August and frequently top  $30^{\circ}\text{C}$ .

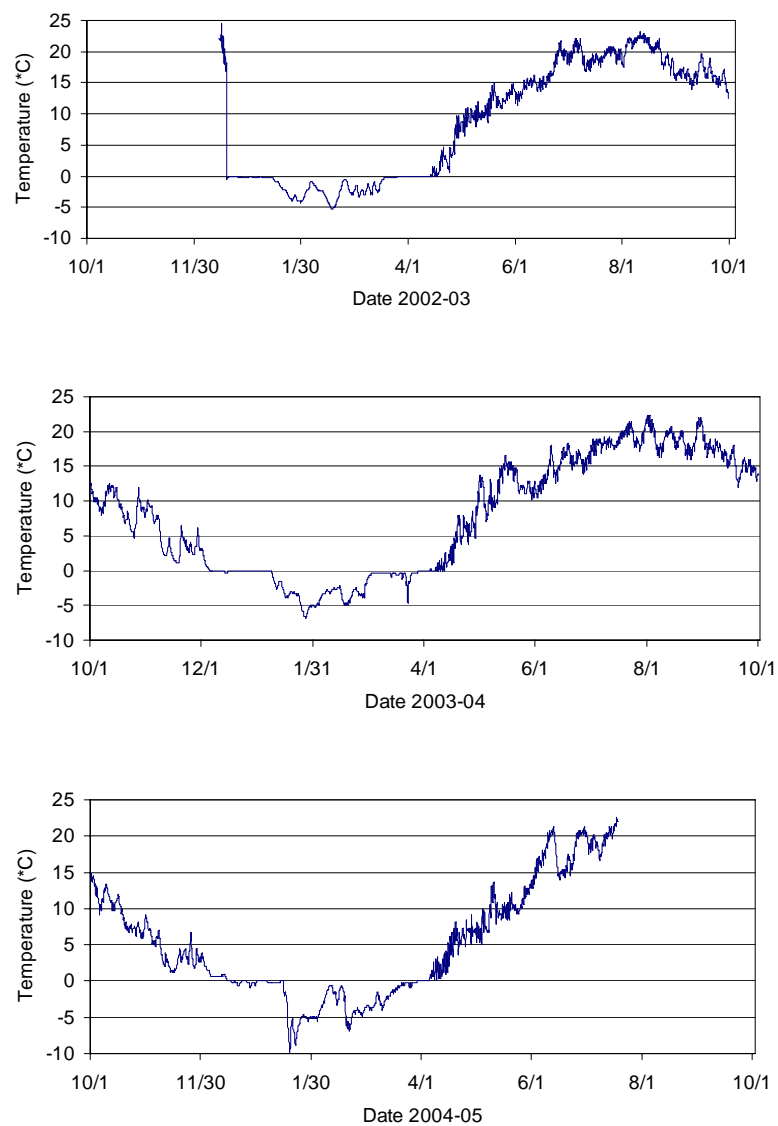
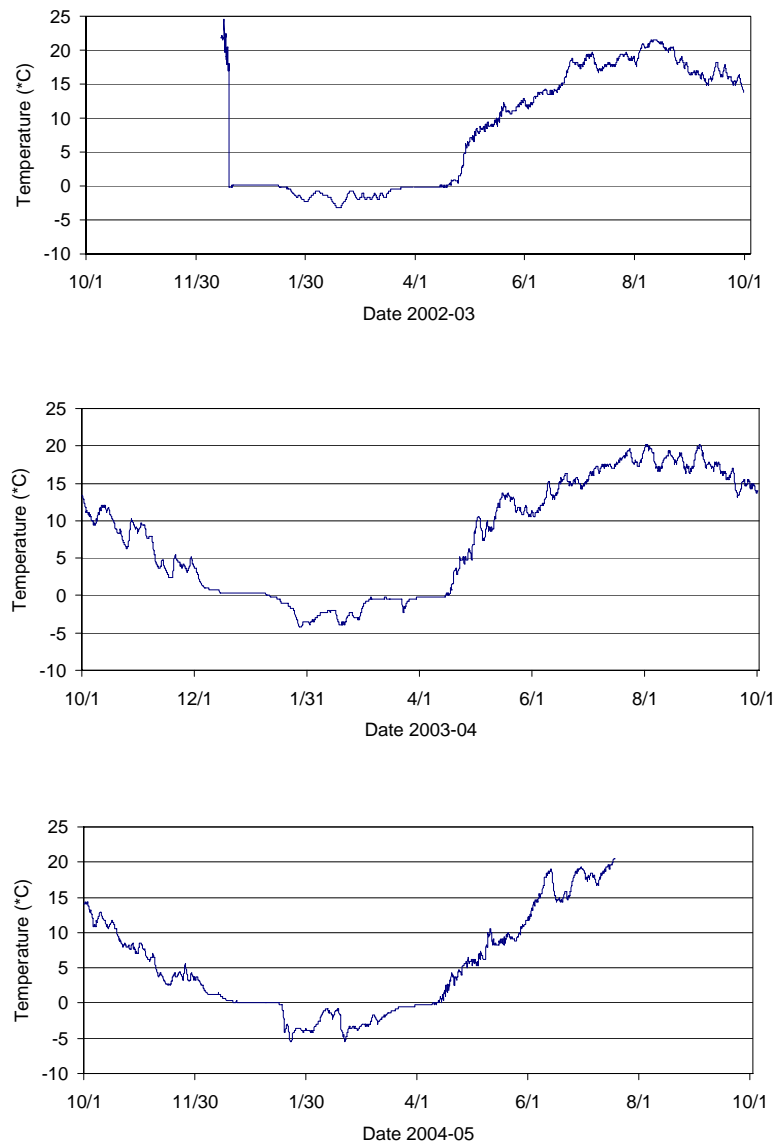
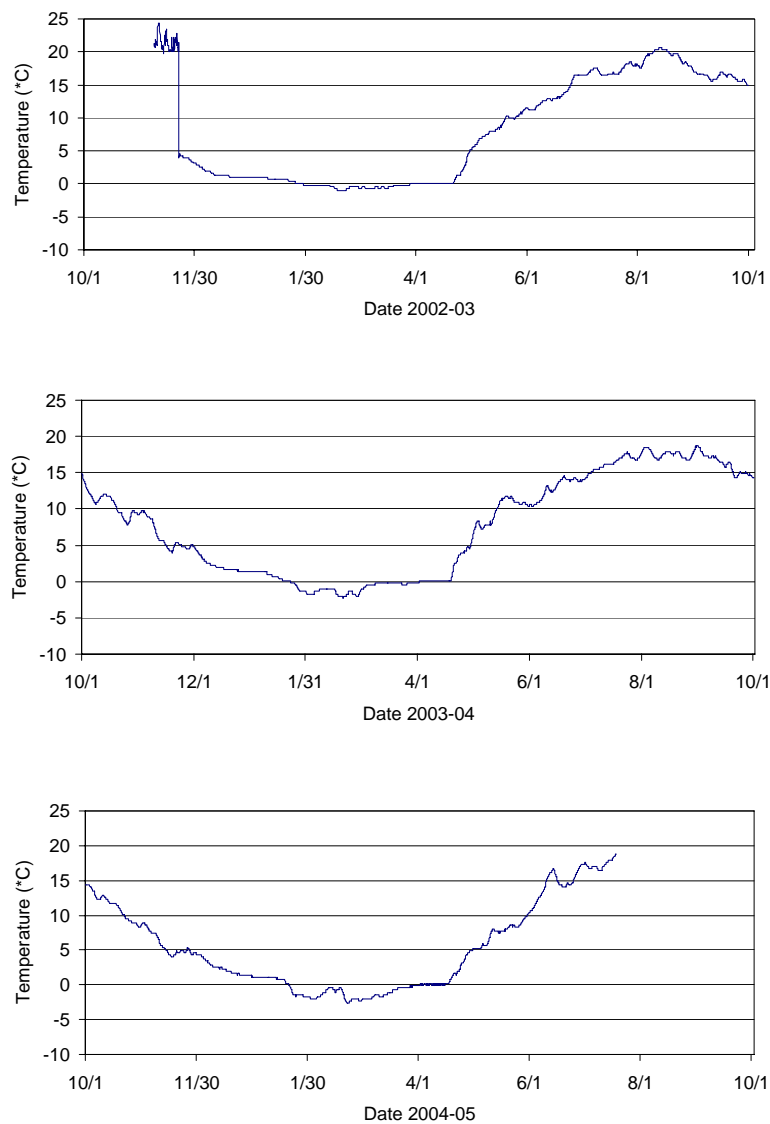
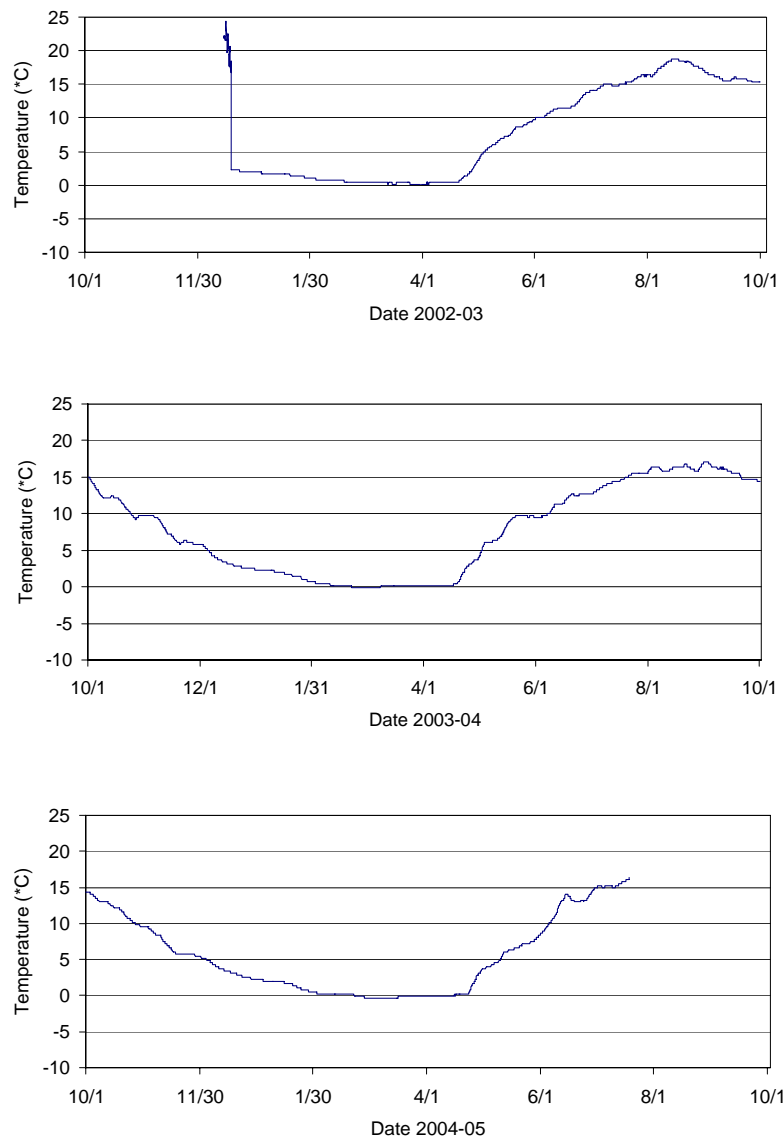
**Figure 12. Soil temperature (°C) at 10-cm depth on the up-land surface of the “instrument” bank profile line.**

**Figure 13. Soil temperature (°C) at 25-cm depth on the up-land surface of the “instrument” bank profile line.**

**Figure 14. Soil temperature (°C) at 50-cm depth on the up-land surface of the “instrument” bank profile line.**

**Figure 15. Soil temperature (°C) at 75-cm depth on the upland surface of the “instrument” bank profile line.**

Winter soil temperature comparisons indicate the importance of local conditions; specifically the presence or absence and depth of snow cover, exposure to solar radiation, and soil moisture. Soil temperatures at 10-, 25-, 50-, and 75-cm depths on the upland surface at the instrument bank profile line are given for each of the study years in Figures 12, 13, 14, and 15, respectively.

Each data record required a period of time following installation before recording the actual soil temperature began. Diurnal and short-term temperature fluctuations are evident at the 10-cm depth (Fig. 12). Diurnal temperature fluctuations are greatly attenuated at 25 cm (Fig. 13), and short-term temperature fluctuations are barely visible at 75 cm (Fig 15). Another change in character that occurs over this depth range is a decreasing temperature range with increasing depth. The duration of soil freezing decreases and the minimum soil temperature

increases as depth increases. The depth of frozen soil extends below 50 cm at this upland location, with a freezing limit in each of the study years that is very close to 75 cm.

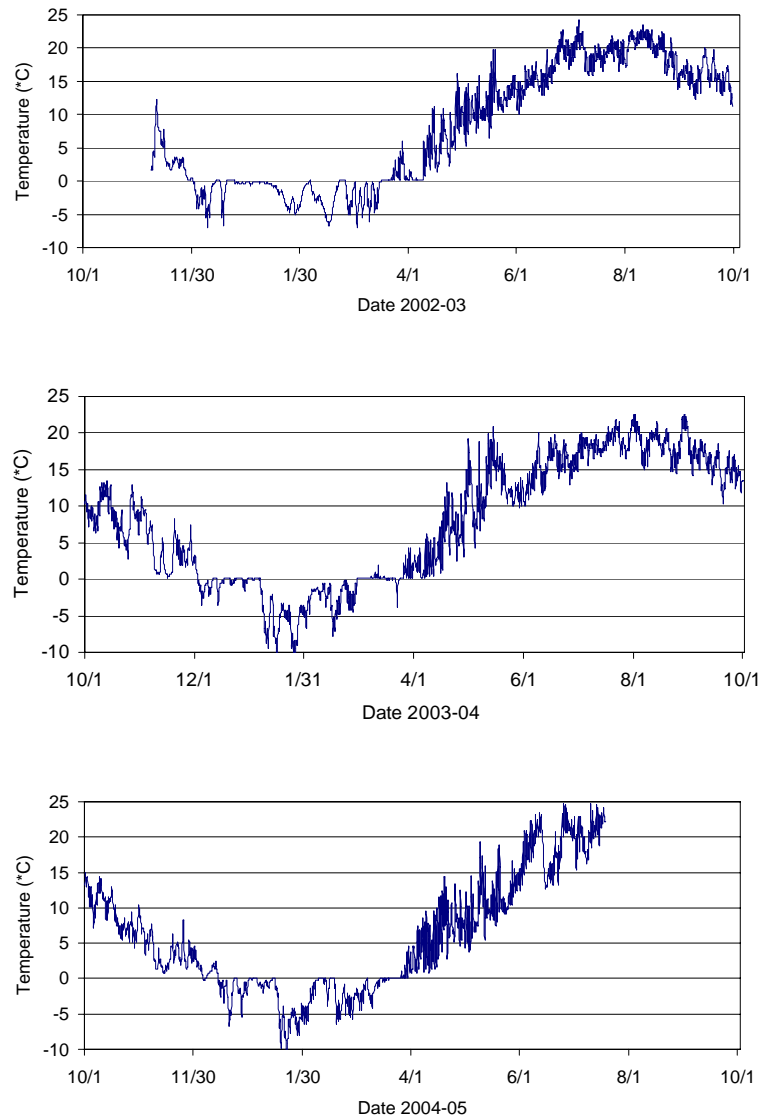
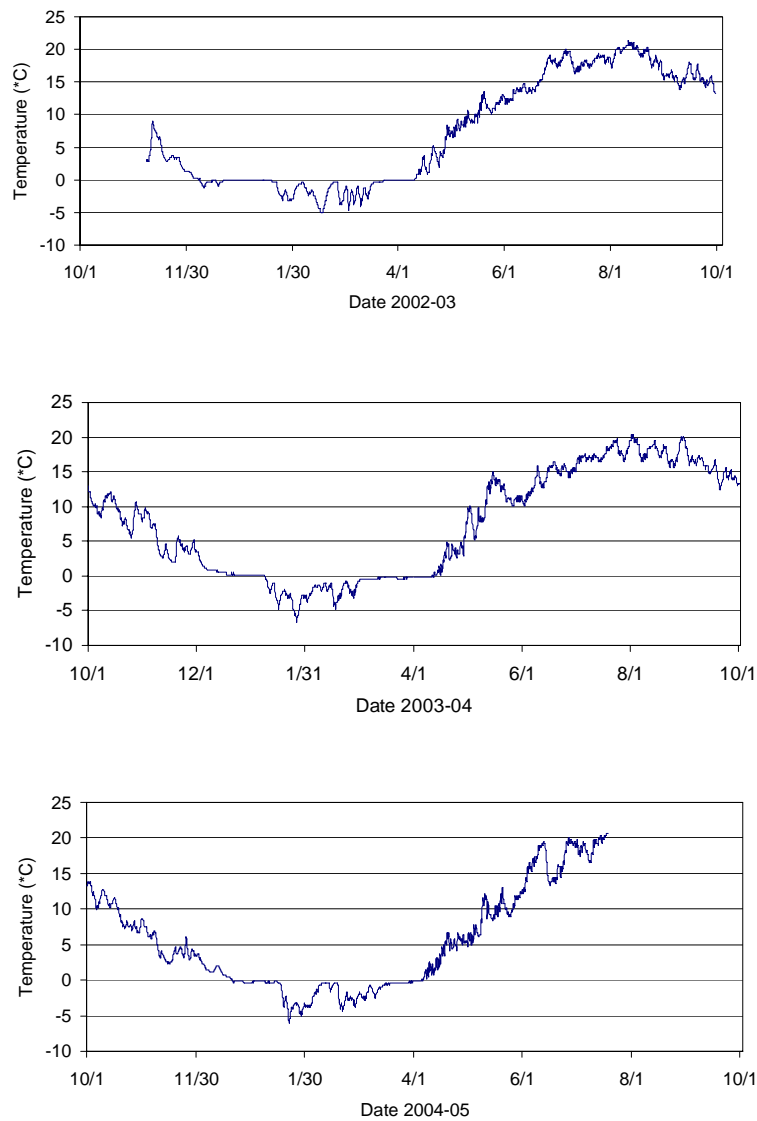
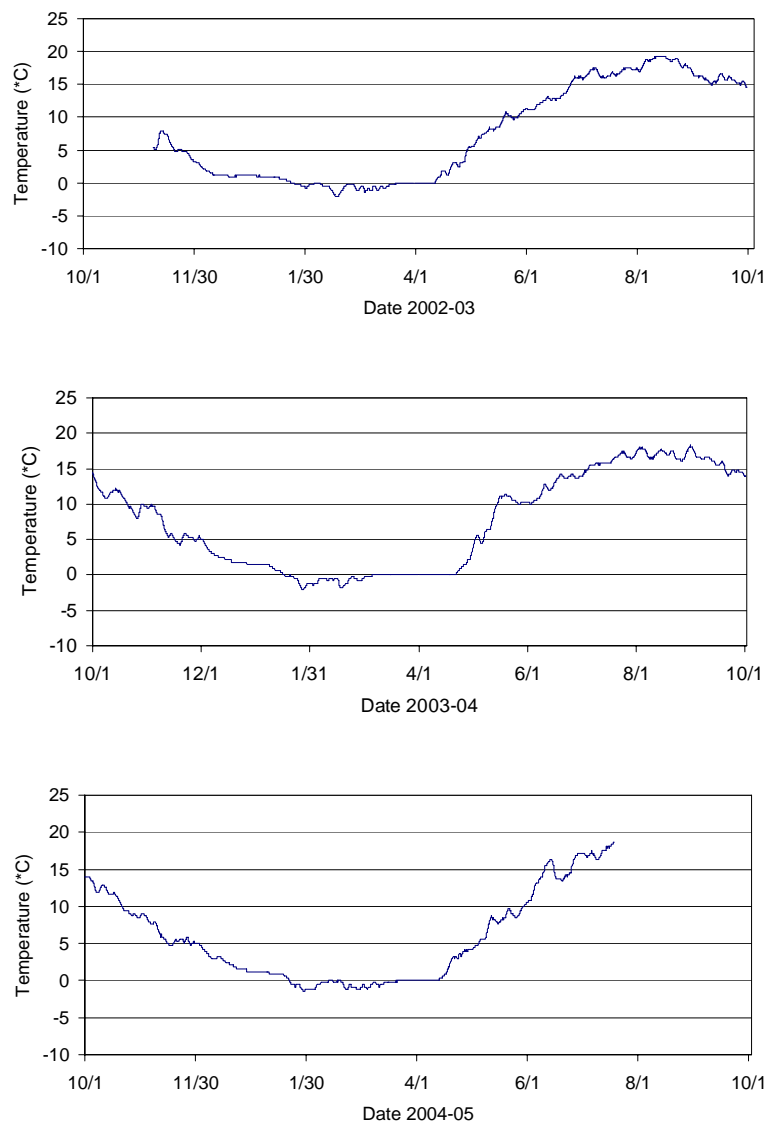
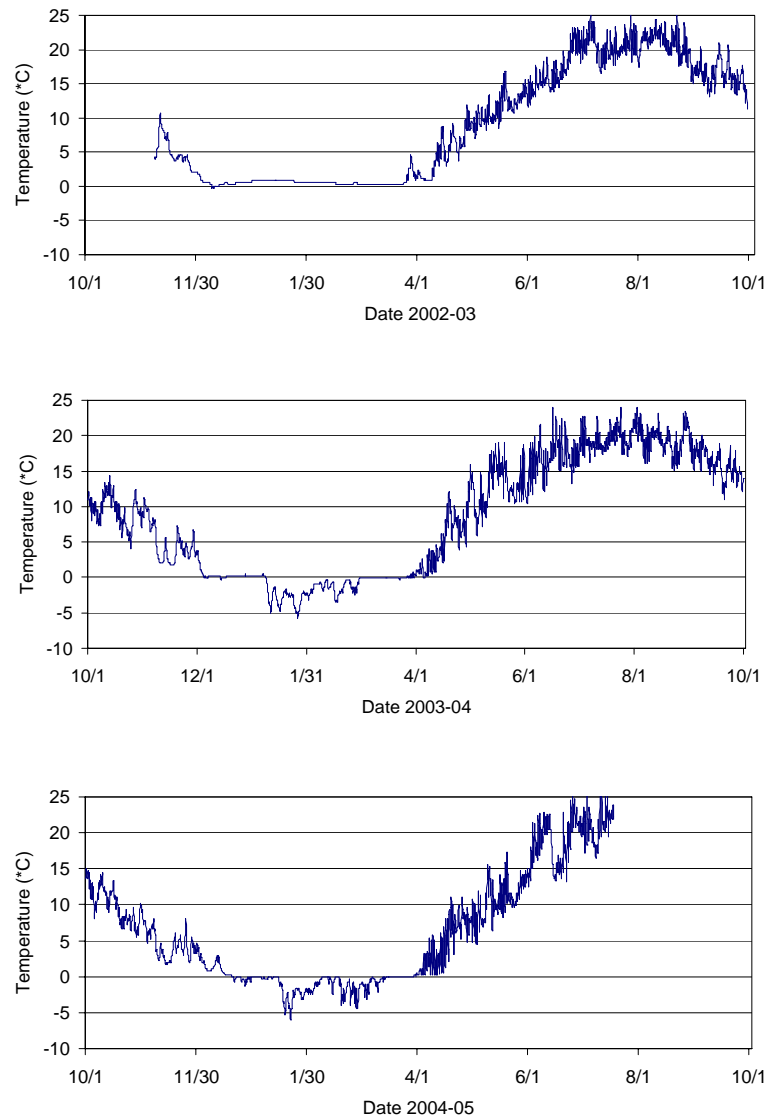
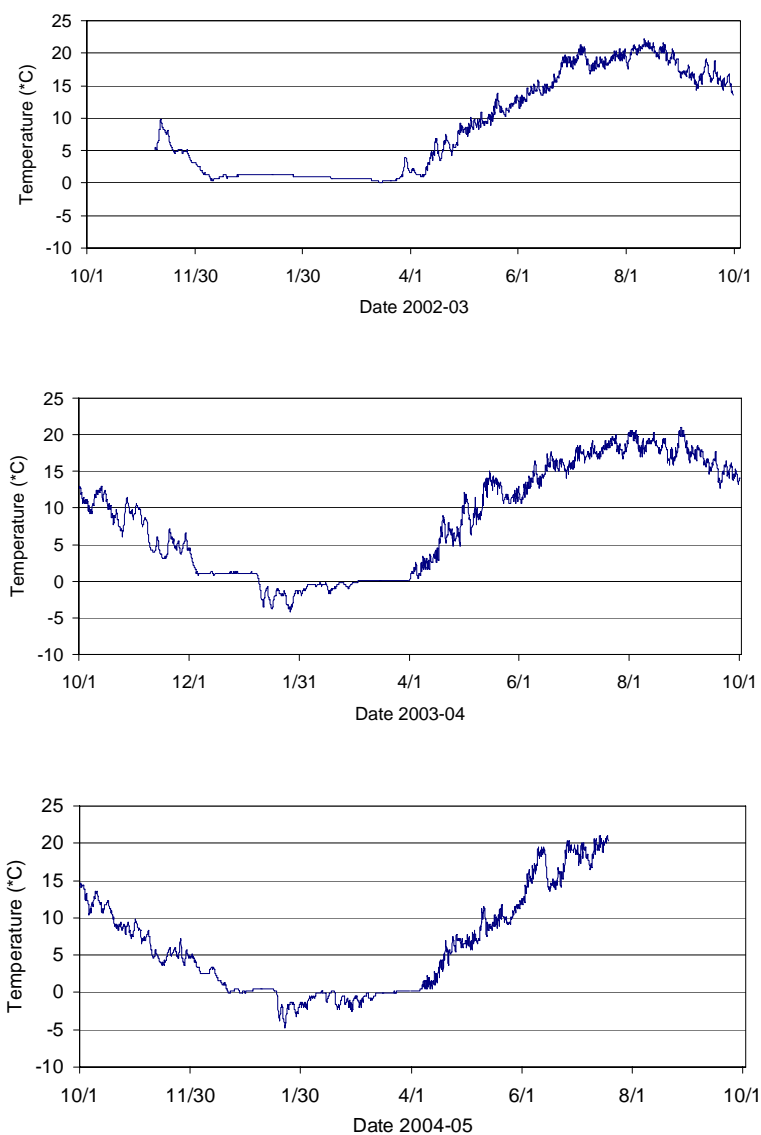
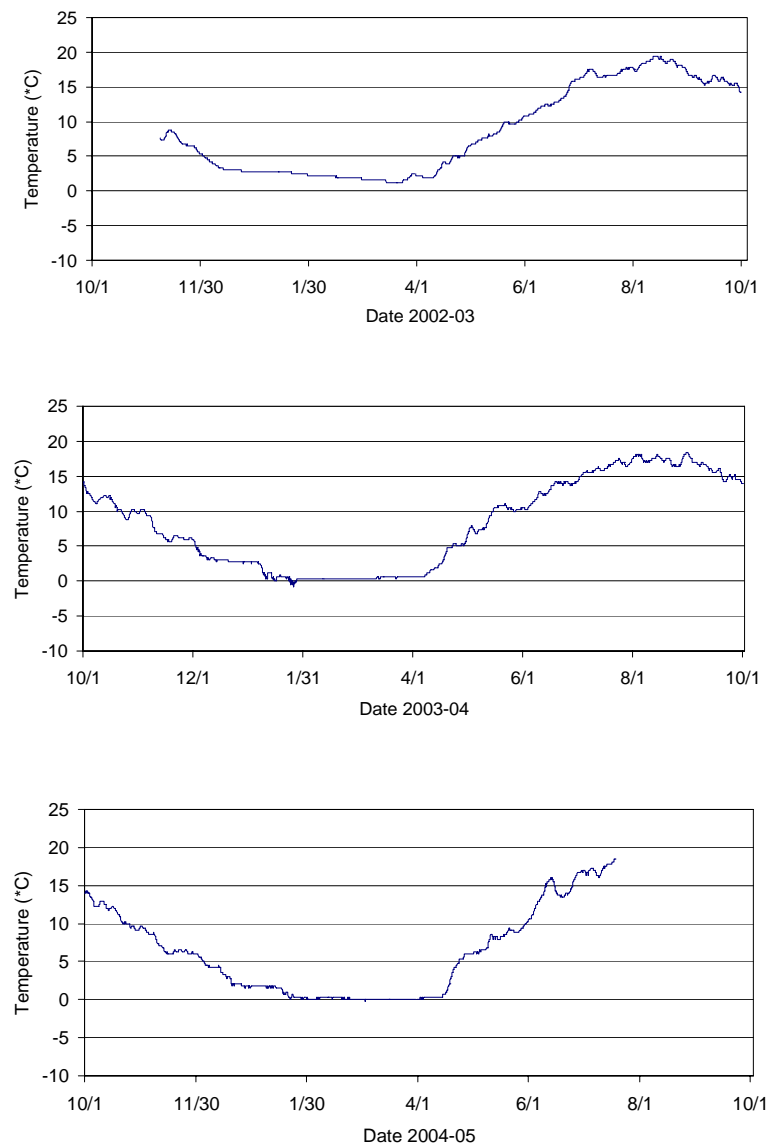
**Figure 16. Soil temperature (°C) at 10-cm depth in the upper east-facing cluster of the “instrument” bank profile line.**

**Figure 17. Soil temperature (°C) at 25-cm depth in the upper east-facing cluster of the “instrument” bank profile line.**

**Figure 18. Soil temperature (°C) at 50-cm depth in the upper east-facing cluster of the “instrument” bank profile line.**

**Figure 19. Soil temperature (°C) at 10-cm depth in the lower east-facing cluster of the “instrument” bank profile line.**

**Figure 20. Soil temperature (°C) at 25-cm depth in the lower east-facing cluster of the “instrument” bank profile line.**

**Figure 21. Soil temperature (°C) at 50-cm depth in the lower east-facing cluster of the “instrument” bank profile line.**

The extent of soil freezing was very different at the upper and lower bank face sites on the instrument bank profile line, separated by less than 3 m. Soil

temperatures for the upper east-facing cluster at 10-, 25-, and 50-cm depths are given in Figures 16, 17, and 18, respectively, and corresponding soil temperatures for the lower east-facing cluster at the same depths are given in Figures 19, 20, and 21.

The upper bank face had freezing temperatures below 50 cm in each of the three winters. In 2002–03, the lower bank face site had minimal freezing at the 10-cm depth and no freezing with temperatures above 1.3°C throughout the winter at 50 cm. At the 10-cm depth in the other years, the upper site had greater diurnal temperature fluctuations and lower minimum temperatures than the same depth at the lower site. Freezing temperatures in 2003–04 and 2004–05 were

comparable between the upper and lower sites at 25 cm, but were again moderated at 50 cm for the lower site. The duration of upper bank soil freezing was always much greater than that of the lower site. Higher soil moisture and greater latent heat release during freezing contribute significant thermal inertia that moderates lower bank soil temperature change. Greater snow depths low on the bank (Fig. 3) may also act to reduce heat exchange and related changes in soil temperature.

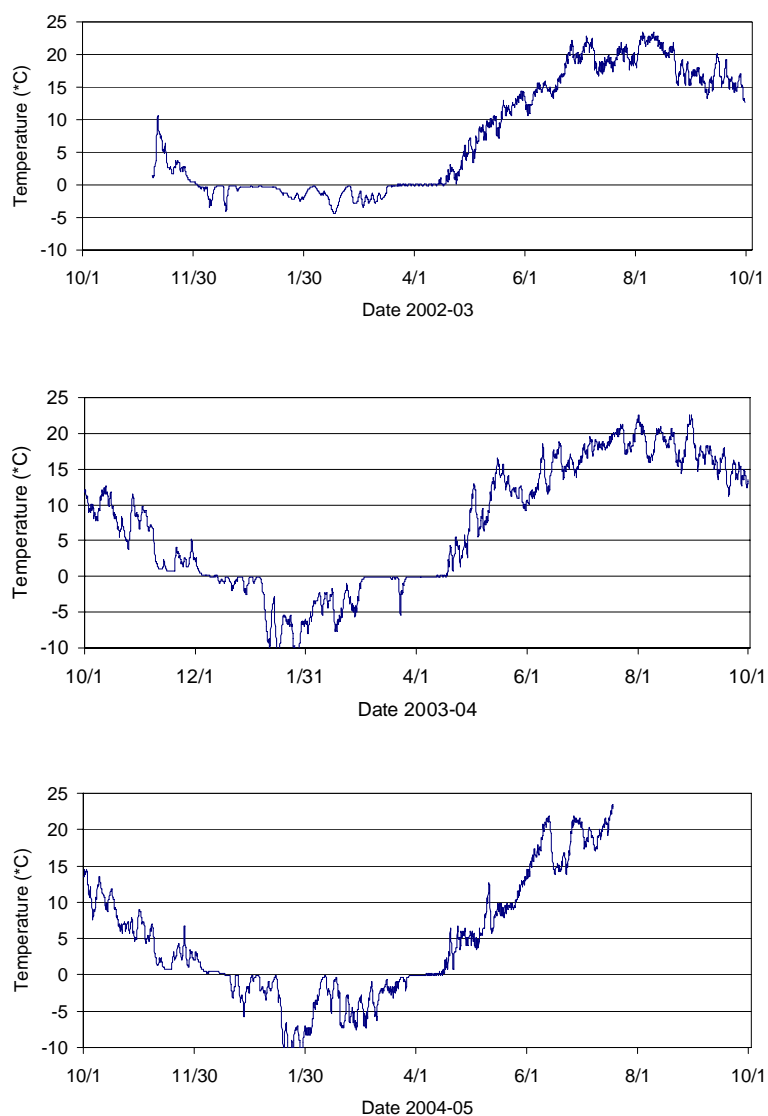
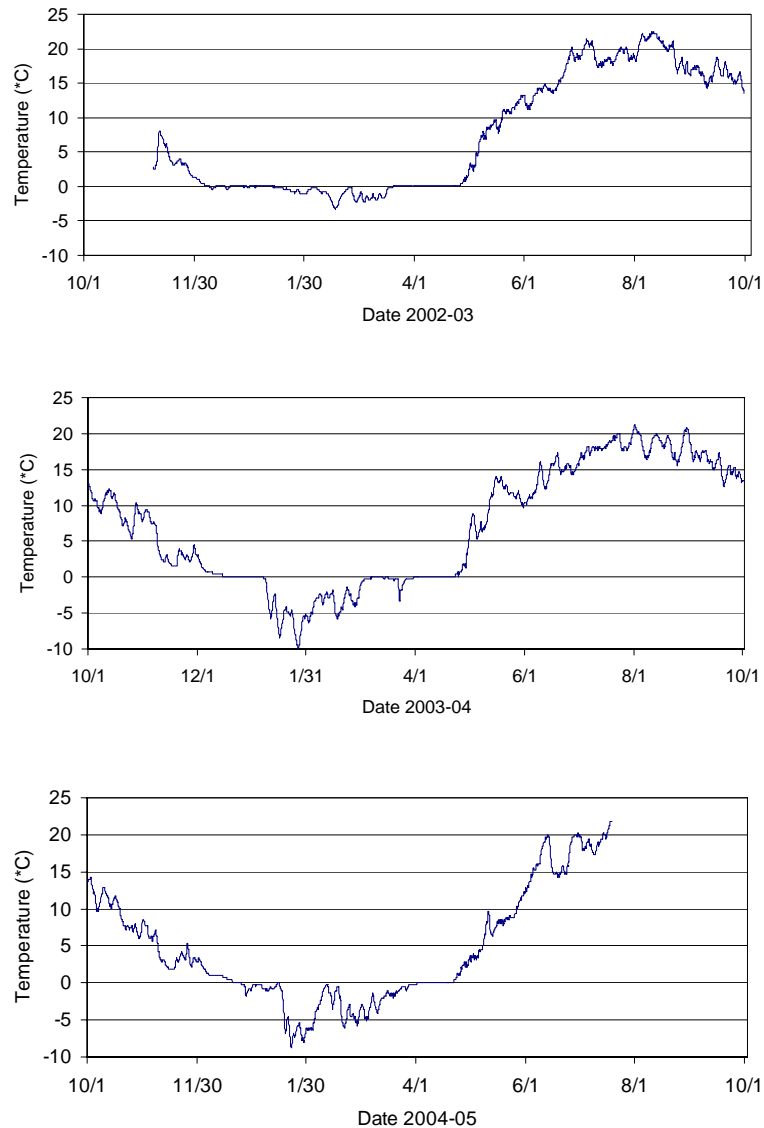
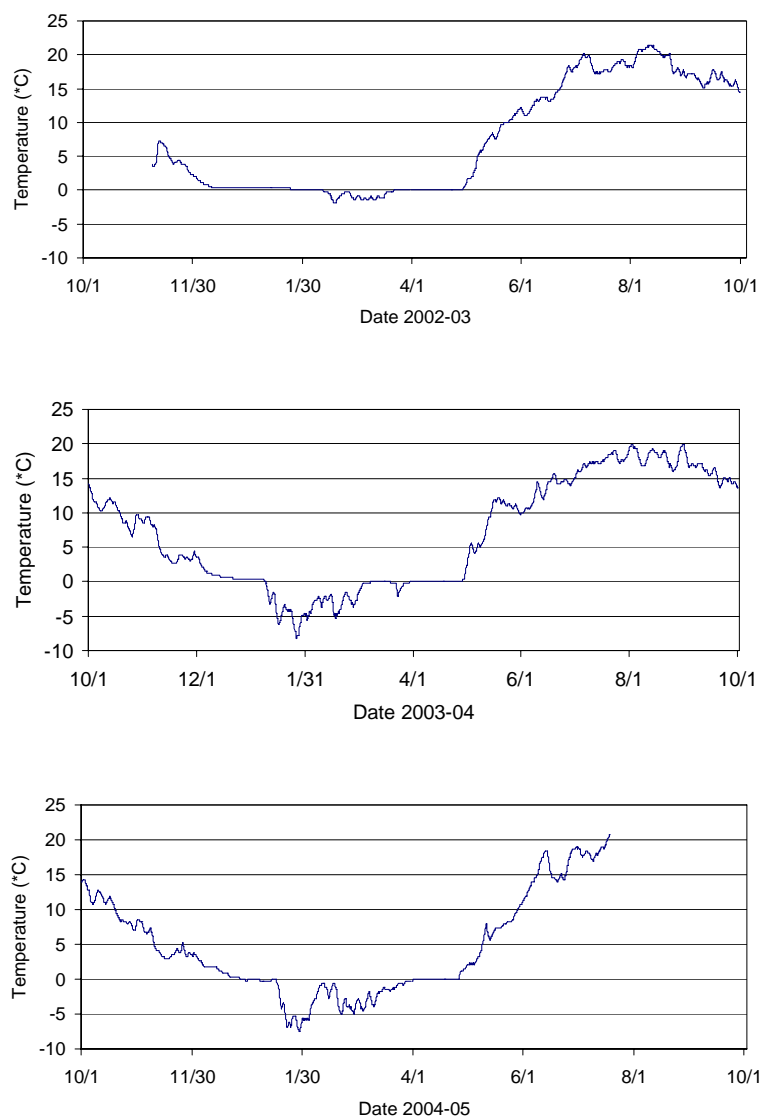
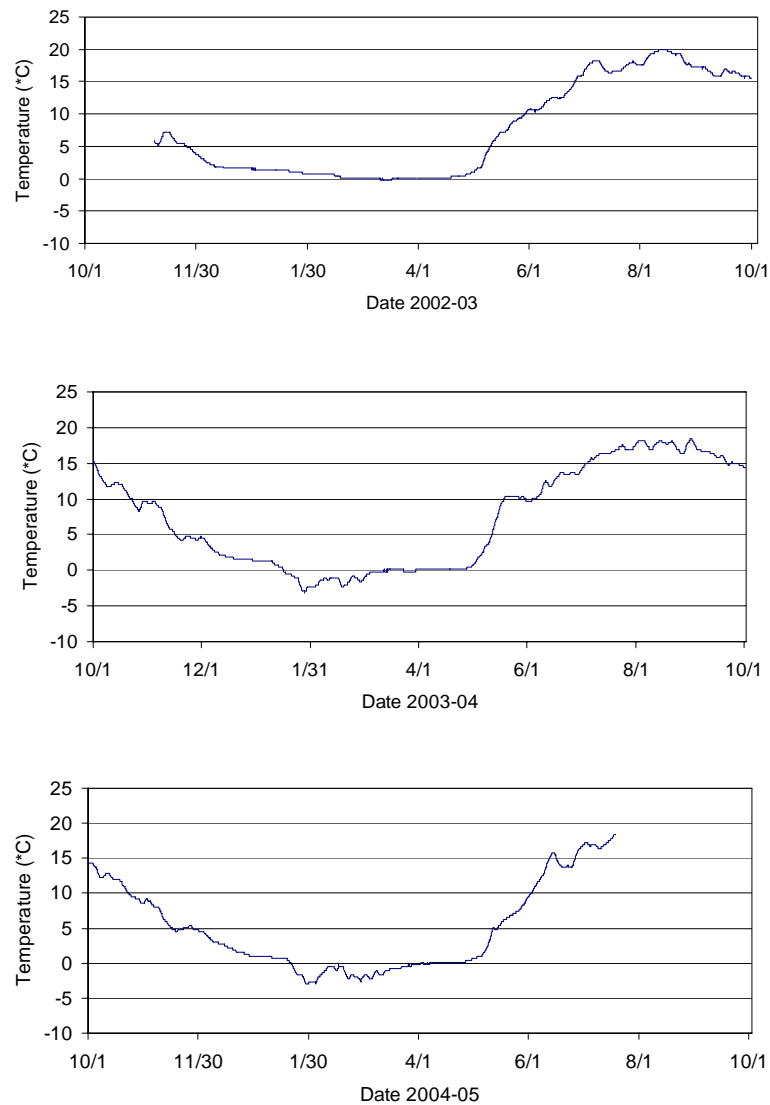
**Figure 22. Soil temperature (°C) at 10-cm depth in the north-facing bank.**

**Figure 23. Soil temperature (°C) at 25-cm depth in the north-facing bank.**

**Figure 24. Soil temperature (°C) at 50-cm depth in the north-facing bank.**

**Figure 25. Soil temperature (°C) at 75-cm depth in the north-facing bank.**

The orientation of the monitored bank was very important to the soil temperature regime. Soil temperatures of the north-facing bank are given in Figures 22, 23, 24, and 25 for the 10-, 25-, 50-, and 75-cm depths.
